Chapter 2

THE ACCOUNT OF WORLD TRADE CENTER 1

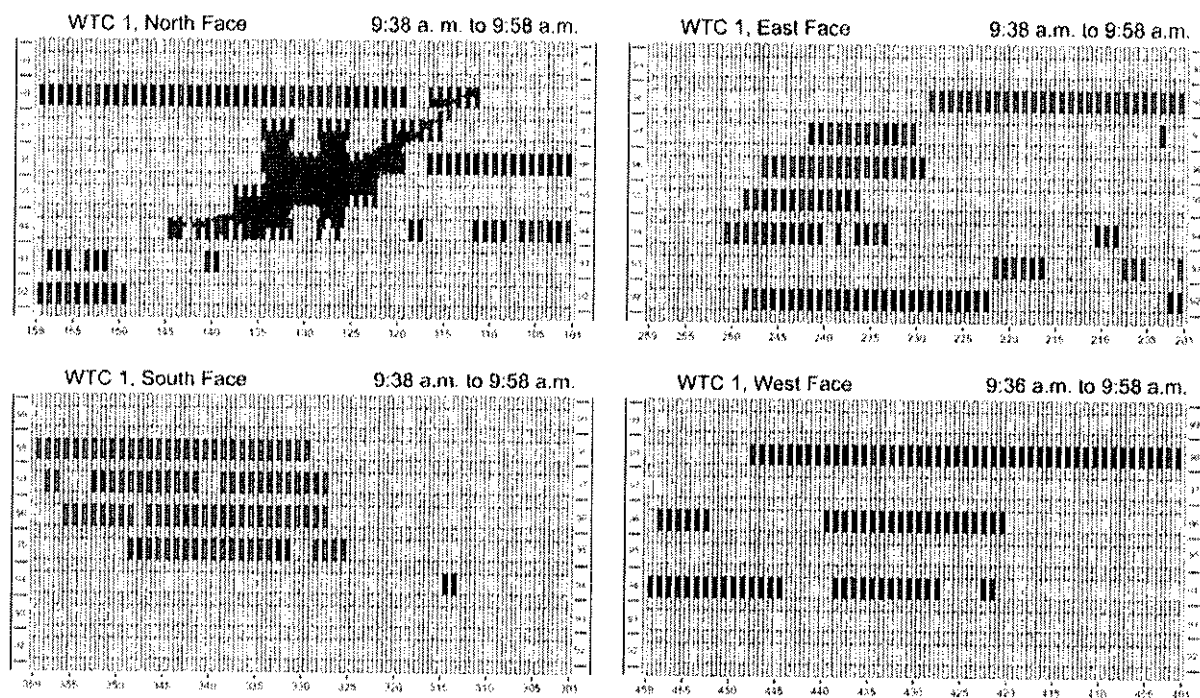
Seventy-five minutes after the impact, approaching 10:00 a.m., the fire on the 97th floor had begun to burn itself out, but the fire on the 94th floor had intensified and filled much of the north half of the floor (Figure 2–7). Starting about 9:30 a.m., there were vigorous fires on nearly the full perimeter of the 98th floor. There was still almost no burning on the 99th floor or above.

Figure 2–7. Representation of exterior views of the fires on the four faces of WTC 1 from about 9:38 a.m. to 9:58 a.m.

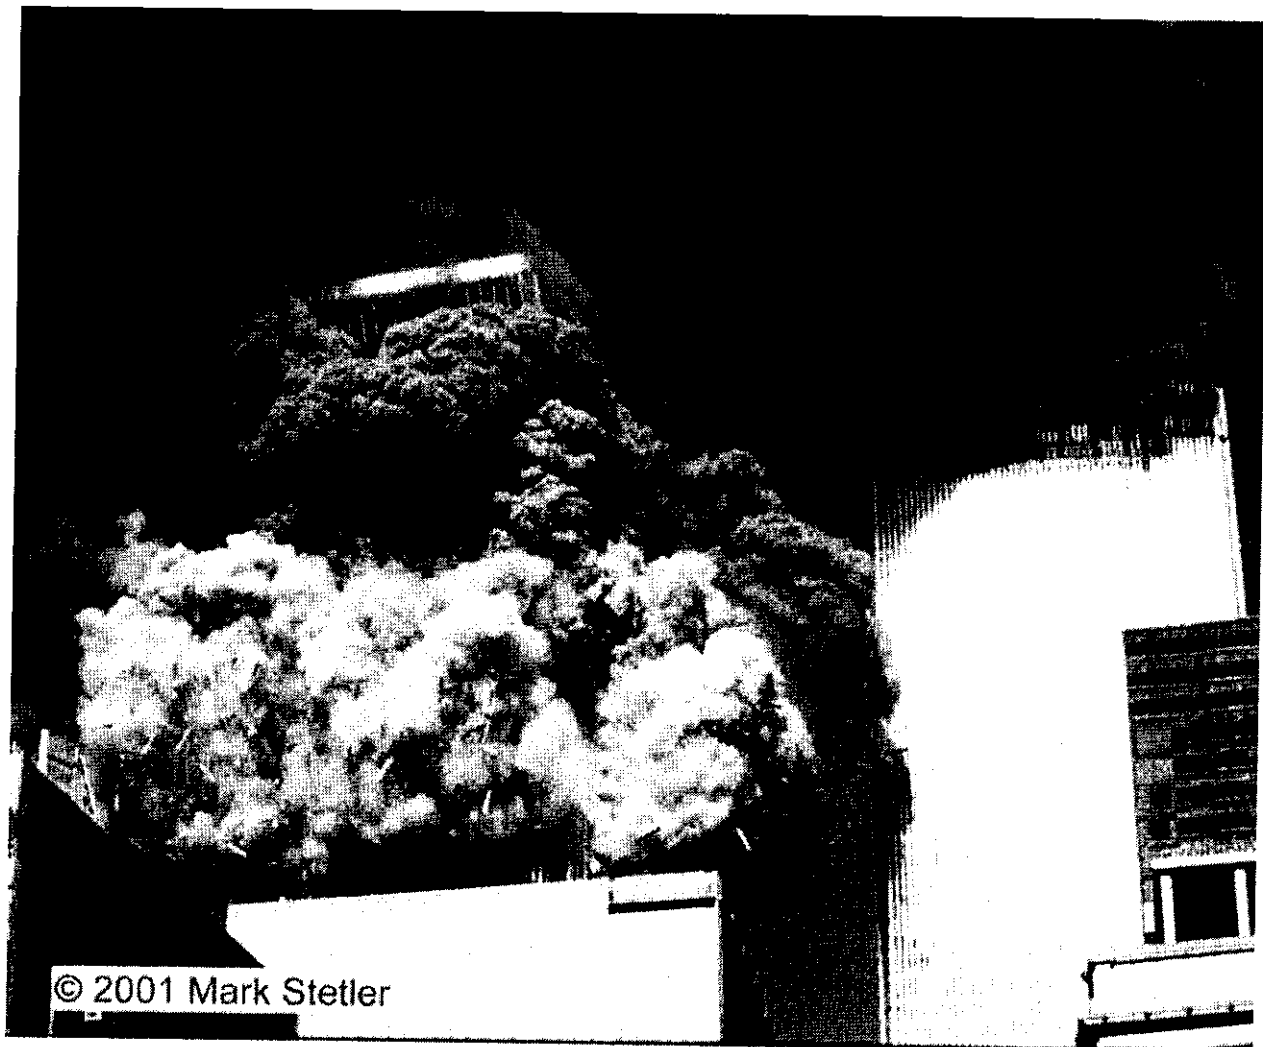
The physical condition of the tower had deteriorated seriously. The inward bowing of columns on the east wall spread along the east face. The east wall lost its ability to support gravity loads, and, consequently, redistributed the loads to the weakened core through the hat truss and to the adjacent north and south walls through the spandrels. But the loads could not be supported by the weakened structure, and the entire section of the building above the impact zone began tilting as a rigid block to the east and south (Figure 3-5). Column failure continued from the east wall around the corners to the north and south faces. The top of the building continued to tilt to the east and south, as, at 9:58:59 a.m., WTC 2 began to collapse.

Figure 3–5. Photograph of WTC 2 tilting to the southeast at the onset of collapse.
